Diesel Engine Failure Analysis

BY DAVE HAGEN

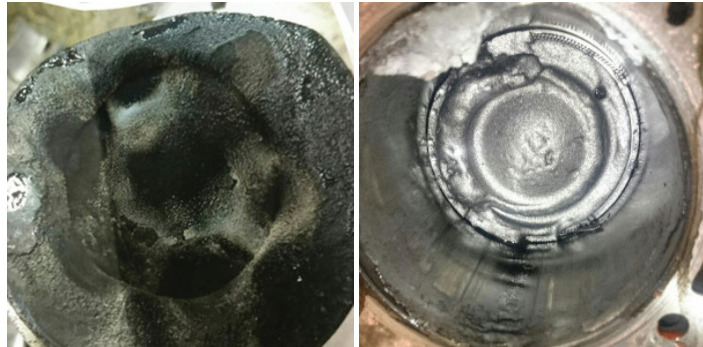
MELTED PISTON

Crown damage by erosion is described as having the piston crown eroded, due to mechanical overloads and thermal disintegration. This is generally caused from excessive and/or premature fuel injection from the anticipated injection point with a lack of oxygen for the fuel available. When this occurs individual fuel droplets can be distributed throughout the entire combustion chamber and end up further outside on the piston crown on its downward stroke. There they glow away under a shortage of oxygen, generating a lot of heat in the process eventually leading to erosion. Ingestion of additional fuel sources (oil or fuel) through the intake can also cause an unregulated injection point in the cylinder, causing piston erosion from not receiving enough air volume to offset the amount of fuel being burned.

As this type of failure is generally caused from excessive/premature fuel injection, incorrect spraying and leaking injector nozzles injectors, they must be removed for testing or replaced with new ones when installing a rebuilt engine. Injectors are not a serviceable item (requires a specialty shop) they should be removed for bench testing or replaced every 90,000 miles (150,000 km).

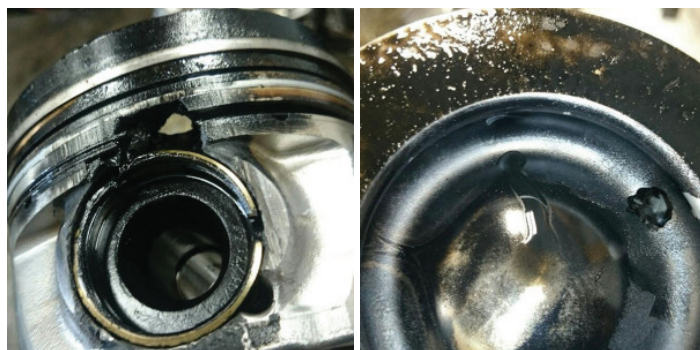
HOLE IN PISTON

During normal engine operation the injector sprays a very fine mist of fuel. The fuel spontaneously combusts as it is injected into the cylinder. Temperatures present in the flame front are much higher than the melting temperature of an aluminum piston. A barrier layer of residual combustion gasses protects and insulates the piston crown from the high combustion temperatures. As a result, the burning fuel doesn't normally come into direct contact with the piston.

If the fuel is not sufficiently atomized (faulty injector), the large fuel droplets do not completely burn with the flame front. The remaining fuel then penetrates the barrier layer of gases and is deposited directly onto the piston crown surfaces. The fuel then burns in direct contact with the piston, creating a very high temperature zone. The high localized temperature heats the crown in this area to a plastic state. The high temperatures also cause the affected portion of the piston to expand much more than the adjacent cooler areas.

The stress created by this can cause the piston to fracture. The fracture creates a passageway that allows high temperature combustion gasses to burn through the crown. This allows engine oil to be drawn into the combustion chamber. The engine oil is then burned as additional un-metered fuel, creating even higher combustion temperatures and additional damage.

Holes eroded through pistons are generally caused by injector nozzles not fully sealing due to deposits of particulate matter in the injector nozzle. This concern can be exacerbated by trucks running high horsepower aftermarket engine tunes especially when only street driving and towing.

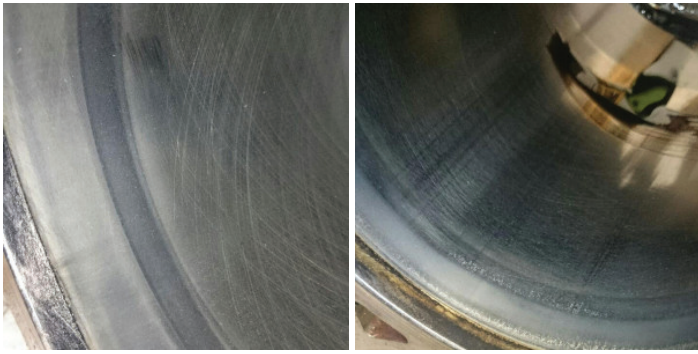
DUSTING

Engine dustings have several characteristics to watch for when assessing a concern and affect all moving parts in the engine. The ingress of dirt allows for the piston ring to be worn on the running surfaces and edges, so they can no longer seal the cylinder sufficiently and can therefore no longer prevent oil from passing into the combustion chamber. At the same time, the pressure in the crankcase increases as a result of combustion gases flowing past the piston rings. This excessive pressure can cause increased quantities of oil to escape through radial oil seals, valve stem seals and other sealing points.

Possible causes for abrasive dirt particles which enter the engine through the air intake are as follows:

- Foreign particles enter past missing, defective, deformed or poorly maintained air filters
- Leaking points in the intake system, such as distorted flanges, missing gaskets or defective or porous hoses
- Particles of dirt which are not completely removed during an engine overhaul
- If first oil change is performed too late, abraded particles from when the engine is run in are then spread through the oil circuit to the other moving parts where the cause more damage

Once abrasive particles have been ingested, the wear between the cylinder wall and piston rings allows the crosshatch in the cylinder to be worn away. As the two primary purposes of cross hatch is to keep the piston ring stationary (so it does not rotate excessively on the piston during engine operation) and hold oil for lubrication. As the cross-hatch wears away, it will cause decreased engine performance, hard starting, and oil consumption.

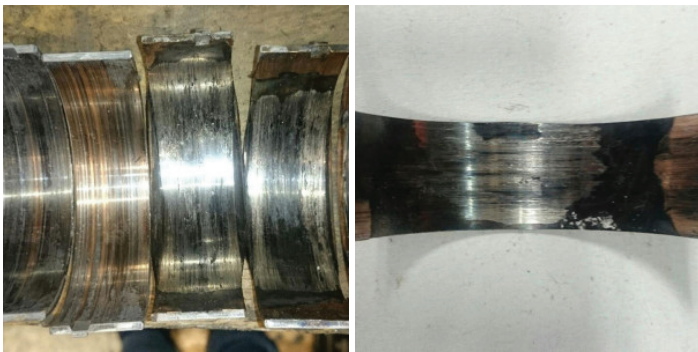
HOT SHORT

A loss or lack of proper lubrication is created when the oil film present during operation is inadequate, either in quantity or quality, to support the loads placed upon it. As a result, the shaft and bearings are allowed to come into direct contact with one another. This action generates accelerated wear, heat, wiping and eventually total catastrophic bearing failure.

Wiping of a bearing occurs when the crankshaft journal comes into direct contact of the bearing surface because the oil film is penetrated. Once the wiping sequence begins, temperatures become elevated by friction of contact. High temperatures cause considerable softening of the bearing material, which leads to the displacement of the material. Severe wiping of a bearing can best be described as an advanced stage of oil starvation which can progress into a hot short condition.

“Hot-Short” is a metallurgical term used to describe the process of which a bearing material is caused to delaminate in the presence of high temperature and shear stress. Once a lack of lube condition has initiated, regardless of the cause, the resulting friction of the bearing operating temperatures to rise quickly. By 375 degrees Fahrenheit conventional engine oils have lost their lubricity and begin to vaporize. Without lubricating oil, bearing temperatures accelerate quickly. As temperatures surpass 620 degrees Fahrenheit, lead in the alloy begins to melt and leach from the alloy intermediate layers microstructure. Under the shear stresses imposed by contact with the rotating shaft, the intermediate layer loses its bond with the steel backing and relatively large areas begin to be torn from the backing material.

If an engine is built with the correct assembly clearances it can still suffer premature failure from running incorrect oil grades for the outside ambient temperature. For example, using a 15w40 in -22° F (-30° C) or colder or a 0w30/10w30 in 50°F (+10° C) or hotter can lead to this concern given the loads placed on the engine. Always reference the factory owner’s manual for proper grades of oil to be using for you conditions.

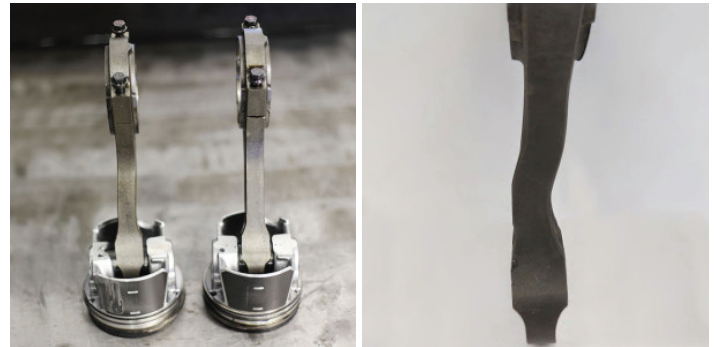
BENT CONNECTING RODS

Hydrostatic lock occurs when a volume of liquid greater than the volume of the cylinder minimum (end of the pistons stroke) enters the cylinder. Since most common liquids are incompressible the piston cannot complete its travel; either the engine must stop rotating or a mechanical failure must occur. Diesel engines are more susceptible to hydro lock than gasoline engines. Due to their higher compression ratios, diesel engines have a much smaller final combustion chamber volume, requiring much less liquid to hydro lock. Diesel engines also have higher torque, rotating inertia and stronger starter motors than gasoline engines. The result is that a diesel engine is much more likely to suffer catastrophic damage from ingestion of incompressible fluids.

Typical causes of this concern are from ingestion of fluids through the intercooler, water in fuel and improper torquing of injector hold down bolts. Always have intercooler and piping professionally cleaned when installing a new engine and follow the original equipment manufacturers recommended torque sequences. If a water in fuel light comes on vehicle should be towed, not driven to a dealer for further inspection.

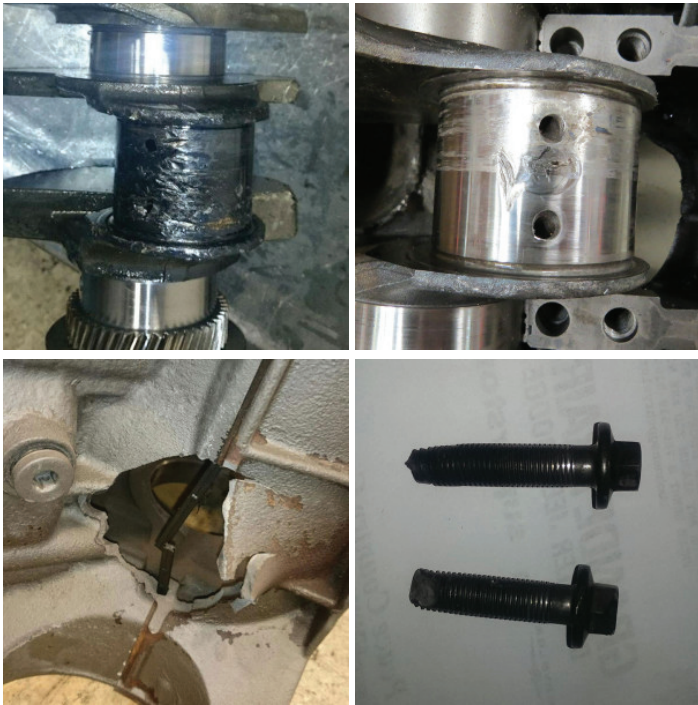
HOLE IN BLOCK (rod bolt failure and bearing failure)

Catastrophic bearing failure can be as a result of both isolated and progressive bearing wear and/or contamination. A progressive failure generally isolates the actual failure towards the end of the engine's oil gallery flow, typically rear of the engine assembly.

This can be from both lack of sufficient oil volume and foreign dust, dirt or abrasives and/or metallic particles present in the oil supply. The foreign particles can embed in the soft Babbitt bearing lining displacing metal and creating a high spot as the material is re-plastered to additional bearing materials while the lack of oil volume will cause a wiping of the bearing surface leading to a "Hot-Short" condition. Evidence of either of these conditions will leave some degree of damage and wear throughout all bearing surfaces with "progressive" damage being exhibited as the oil flow travels through the engine creating more debris.

Catastrophic connecting rod failure can be as a result of incorrect clearances causing bearing failure, incorrect torque applied to the fasteners, engine over speeding resulting in hyper-articulation of the connecting rods and connecting rod bolt failure.

Incorrect clearances will result in seizure of the connecting rod bearing. Once started, through continued operation, the friction, debris and heat generated by the seizure of that bearing can cause the oil to vaporize and create a lack of lubrication condition commonly shared with its partner connecting rod in V8 applications sharing the same rod journal. The generated heat will remove the hardness from the crankshaft, leaving a blackened appearance. With the continued operation this can lead to the connecting rod to disengage from to crankshaft and collide with the rotating assembly. A series of high energy collisions can create a high degree of secondary damage to the engine assembly.

Incorrect torque applied to the fasteners can be observed typically by at least one if not both bolts still intact with collateral damage from a subsequent high energy collision within the engine assembly. As most connecting rod bolts require an engineered amount of "stretch" to maintain torque, once loose can work their way out of their threaded end within seconds. This leaves the bearing lacking any evidence of a lubrication or contaminant concern with the crankshaft journal still polished in appearance with only

the subsequent collateral damage caused from the connecting rod disengaging from the crankshaft.

Engine over speeding can be as a result of down shifting an automatic or manual transmission in too low of gear for the current vehicle speed, operating the engine at a higher than designed engine rpm from aftermarket tuning and sudden drivetrain failure on a loaded engine causing unregulated engine rpm gains through inertia. As this failure can happen suddenly it typically leaves the condition of a relatively undamaged bearing and crankshaft journal, excluding collateral damage from the resulting high energy collision, but leaves the threaded end of the connecting rod bolts in the upper connecting rod assembly. This is possible from the bolts achieving their tensile stress point and break at the mating surface where the cap meets the connecting rod.

Connecting rod bolt failure generally leaves the condition of at least one bolt with the head broken off, the bolt split at an angle down its length and the opposing bolt broken off within the upper connecting rod half. This can result in a sudden catastrophic failure resulting in a high energy collision with the connecting rod, crankshaft and block assembly but will leave the crankshaft and bearing assembly with their previous polished appearance with only collateral damage from the collision being observed.

Failure of bearings and rods from contamination and/or oil flow issues are generally as a result of failure to replace an oil cooler from a previous engine failure, inadequate oil amount, missing oil gallery plugs, worn oil pump and blocked oil galleries. Incorrectly torqued fasteners will generally cause failure within the first few thousand kilometers/miles and failure as a result of engine over speeding typically shears both rod bolts off flush the machined or fractured connecting rod joint.

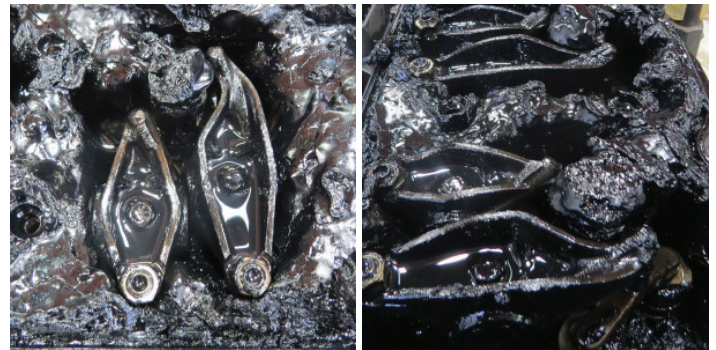
LACK OF MAINTENANCE

Modern diesel engines require the use of a new CJ-4 grade of engine oil. This oil works in conjunction with the new emissions systems such as the EGR (exhaust gas recirculation) DPF (diesel particulate filter) and DEF (diesel exhaust fluid). The goal of these new oils is to help meet emissions by emulsifying excess diesel fuel into tiny droplets within the oil so they can be flushed out at the next service interval. While this practice normally does not cause any excessive bearing or ring wear when proper service intervals are maintained, it can cause a buildup of sludge over time that will lead to premature bearing failure. This sludge buildup normally takes in excess of 20k oil change intervals to start accumulating and can cause catastrophic failure when operated to 50k plus without servicing. This happens through what is defined as a "Hot Short" condition when the lubrication value of the oil cannot support the loads placed upon it and the crankshaft comes into direct contact with the bearings.

This concern is 100% avoidable with proper service intervals.

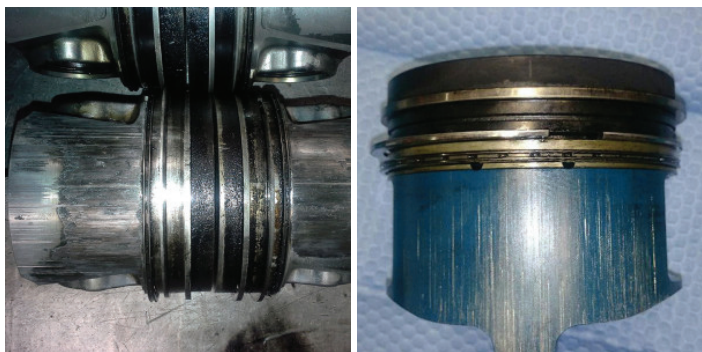
FUEL FLOODING / CYLINDER WASHING

Dry running damage from fuel flooding happens when unburned fuel is wetting the cylinder running surface and has washed off the load bearing oil film. As a result, the piston and cylinder run dry against each other resulting in long, narrow friction marks. This type of damage generally leaves the ring zone undamaged as mainly just the piston rings are in contact with the cylinder running surface. This can be caused most commonly by an over rich operation of the engine, insufficient compression or oil dilution by frequent short distance driving with an overly rich fuel mixture.

Cylinder washing is typically caused from two main causes of either an injection system or lubrication system deficiency. For the injection system the main causes of cylinder washing are connected to an incorrect regulation of the injection pump and nozzles, resulting in a series of changes: quantity of delivered diesel fuel,

injection pump rotation, synchronization between governor and pump, synchronization among pump elements, opening pressure and projection of the injector nozzles out of recommendation and the height of the piston crown.

The lubricating oil has a series of functions, two of them are: to participate in the cooling of the internal engine components and to reduce the friction between moving parts. When the combustion occurs at the piston crown, the generated heat is dissipated by the piston rings (mainly by the top ring in first groove). The rings transmit the heat to the cylinder walls and to the existing lubricating oil. The oil film formed between the piston rings and the cylinders reduces considerably the friction, avoiding the direct metal to metal contact. A worn out oil pump will reduce its pumping capacity, having as a consequence, the reduction of pressure in the oil circuit, and jeopardizing the engine lubrication, originating in this way the above mentioned damages.

This concern can be even more prevalent during the initial break-in of the engine leading to oil consumption. It is important to always have your injectors tested or replaced when installing a remanufactured engine and perform regular fuel filter changes to avoid injector failure.

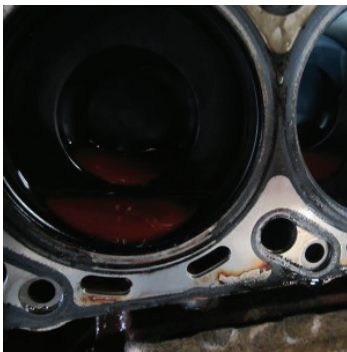
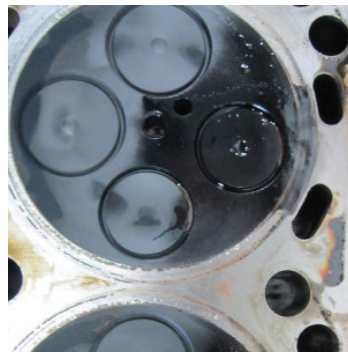
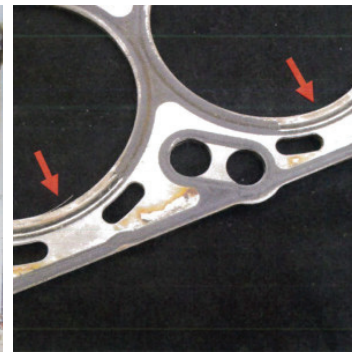
Head Gasket Failure

Conventional machining operations cannot provide the very fine OEM surface finish required for a long-term seal when utilizing an MLS (multiple layer steel) cylinder head gasket. An overly course surface finish (rougher than 20-30 Ra) produces patterns of peaks and valleys in the mating surface that an MLS gasket cannot conform to. When installed the gasket is supported by the peaks in the surface. The valleys between them then become voids which allow fluid and combustion leakage to initiate which eventually leads to a catastrophic failure of the gasket. An overly course finish also abrades the gasket facing as the castings grow and shrink through cycles of thermal expansion.

It is indisputable that the Ford Powerstroke engines have a propensity for cylinder head gasket failures. The root causes for many of these failures are unrelated to the sealing joint itself and cannot be detected by an examination of the cylinder head gaskets alone. Cylinder head gasket failures and other engine damage occurring in these engines have found to be directly linked to hydrostatic lock from injector and EGR cooler failures. Another very common root cause for cylinder head gasket failures in this engine are as a result of excessively high cylinder pressures through the utilization of aftermarket performance tuning programs. To produce a viable seal, the gasket relies on an even application of adequate amounts of clamping force. The excessively high cylinder pressures produced by aftermarket performance tuners and hydrostatic lock effectively lift the cylinder head off the cylinder block reducing clamp load applied to the gaskets, breaking the combustion seal and initiates leakage.

Common repeat head gasket failures can be as a result of porosity in the

block or head casting caused from expanding coolant between the surfaces and are compounded by technicians that use air operated tools to clean surfaces before re-assembly.

Building an engine with a stainless-steel wire O-ring located in the cylinder head or block surface will add additional contact pressure on the combustion ring of the head gasket and may virtually eliminate premature head gasket failures from aftermarket tuning and heavy-duty applications.

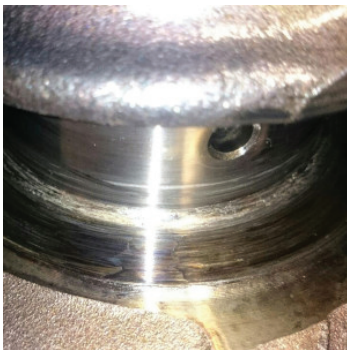
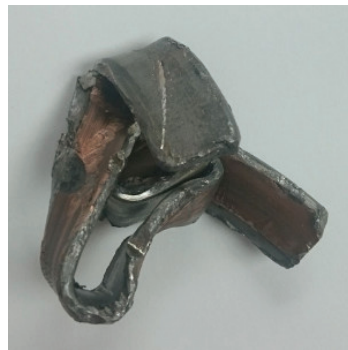
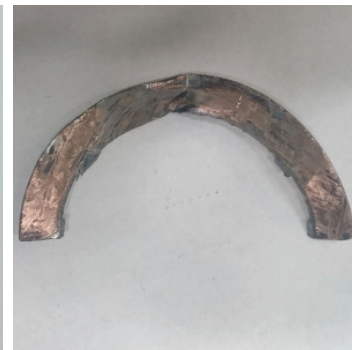
Failed Thrust Bearing

A thrust bearing rear facing (major) thrust side found to exhibit severe thermal discoloration and scoring wear can be attributed to two main causes. These can include a lack of proper lubrication and excessive exterior force being applied to the rear of the crankshaft via the vehicle's transmission clutch, torque converter transmission or driveline.

A lack of proper lubrication simply means that the oil film present at some point was not adequate to support the loads placed upon it. This is a result of either a lack of oil film quality or quantity. In general, a lack of oil film quality can result in the degradation of the lubricating oil due to either contamination or dilution, abnormally course mating surface finish, improper clearance,

geometric misalignment or the bearing surface in relation to the crankshaft or a physical mechanical overload. A lack of quantity can be the result of inadequate pre-lube during assembly or inadequate

volumes of supply oil during operation. A lack of quality or quantity of oil can generally be ruled out as a cause for rear (major) thrust side failure if the remainder of the bearings in the engine show no signs of a quality or quantity of oil starvation.

The most common case of a rear (major) thrust side failure is an excessive exterior force being applied to the rear of the crankshaft via the vehicle's transmission clutch, torque converter transmission or driveline. This force can be the result of improper torque converter or clutch input shaft engagement or clearance. It can also be the result of improper chassis/or driveline geometry and/or damage.

These types of failures will most commonly happen within 3,000 miles (5,000 km) after installation when directly caused by an engine or transmission installation concern whereas if failed after a period of time 30,000 miles (50,000 km) plus, it is more likely as a result of a slipping torque converter clutch causing swelling of the torque converter. In Dodge, Ford and Chevy diesel applications it is not typical to see a worn out thrust bearing solely from clutch pedal application.

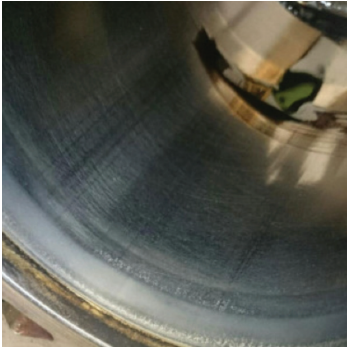
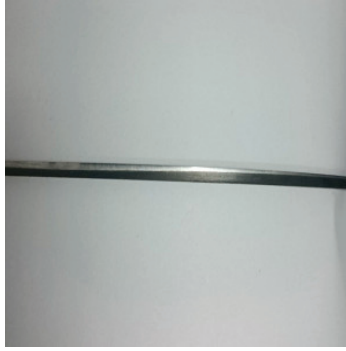
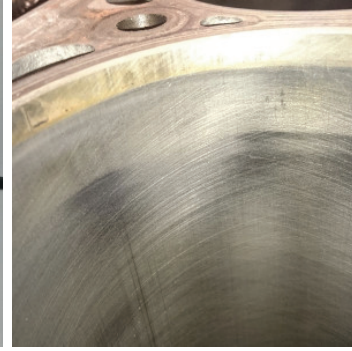
Oil Consumption

Opinions on what constitutes excessive oil consumption can differ widely in practice and from one engine manufacturer to another. Every engine manufacturer has guideline values and limits they follow for the oil consumption of each of their engines. A general guideline for most engine manufacturers of each engine is 0.25% to 0.5% of the actual fuel consumption.

For example, a truck that uses 40 liters of fuel in 100 km is 400 liters in 1000 km. 0.25% of 400 liters equals 1 liter of oil. At 0.5% of 400 liters equals 2 liters of oil. While these limits seem extreme the actual oil consumption of the engine will be determined by several factors. Most commonly ranging from low quality mineral oils, leaking radial oil seals and valve guides, running in phase, cylinder distortion and machining faults during honing.

Low quality mineral oils can cause oil consumption through accelerated wear during cold starts and overly high temperatures. The proper grade and viscosity should always be followed according to the manufacturer's specifications for the outside ambient temperatures and operating conditions.

Leaking radial oil seals such as stem seals around intake and exhaust valves and valve guides can allow oil to enter to the intake and exhaust tract where they can be either burned or discarded.

Oil consumption issues of a newly remanufactured engine when cylinder distortion and cylinder finish are not a factor are typically from incorrect break-in procedures, over fueling injectors and poorly maintained/installed air filter system.

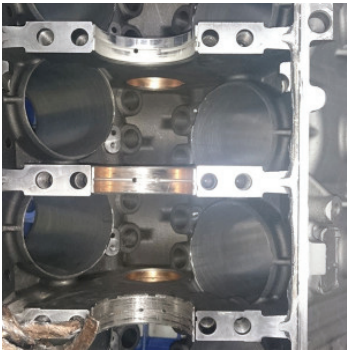
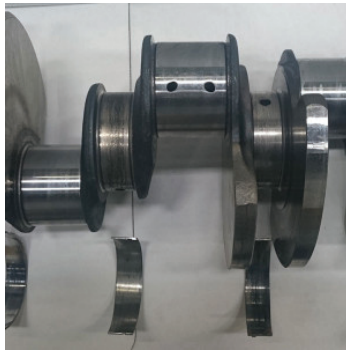
Distorted Crank/Mainline

A distorted crankcase gives the appearance in the bearings of accelerated wear on both the upper and lower shells, usually originating in the center main working outwards. The degree of wear from bearing to bearing varies depending on the nature of the distortion. The point of the greatest load on the bearings causes the greatest distortion (center main). With too much distortion extreme bearing wear can be experienced which can lead to reduced oil clearance. This reduced clearance can lead to metal to metal

contact resulting in further failures such as a “Hot Short” condition.

Any engine built with a distorted crankcase mainline or bent crankshaft will fail in a short period of time usually less than 1,200 miles (2,000 km). Any engine that develops a distorted crankcase mainline during its service life is generally due to an overheating concern.
