Diesel Engine Failure Analysis

BY DAVE HAGEN

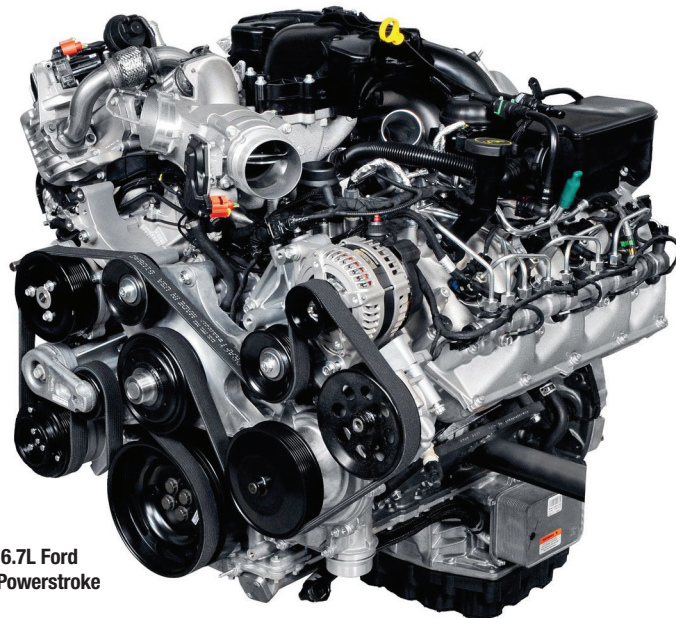
6.7L Ford Powerstroke

MELTED PISTON

Crown damage by erosion is described as having the piston crown eroded, due to mechanical overloads and thermal disintegration. This is generally caused from excessive and/or premature fuel injection from the anticipated injection point with a lack of oxygen for the fuel available. When this occurs individual fuel droplets can be distributed throughout the entire combustion chamber and end up further outside on the piston crown on its downward stroke. There they glow away under a shortage of oxygen, generating a lot of heat in the process eventually leading to erosion. Ingestion of additional fuel sources (oil or fuel) through the intake can also cause an unregulated injection point in the cylinder, causing piston erosion from not receiving enough air volume to offset the amount of fuel being burned.

As this type of failure is generally caused from excessive/premature fuel injection, incorrect spraying and leaking injector nozzles injectors, they must be removed for testing or replaced with new ones when installing a rebuilt engine. Injectors are not a serviceable item (requires a specialty shop) they should be removed for bench testing or replaced every 90,000 miles (150,000 km).

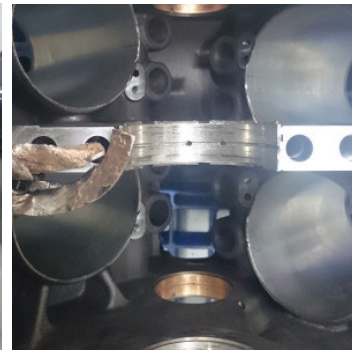
Distorted Crank/Mainline

piston rings and cylinders caused from the ingress of dirt.

Installation of cylinder head studs in some applications can lead to cylinder distortion that exacerbates this situation. Improper break-in
