# Thrusted Into Success

BY CHUCK LYNCH

Engine builders know that crankshaft end play is an important measurement that must be strictly adhered to, but do we understand what other parameters impact the performance and longevity of the thrust bearing? The measurement of crankshaft end play alone does not really quantify critical specifications of the crankshaft, bearings, and the cylinder block.

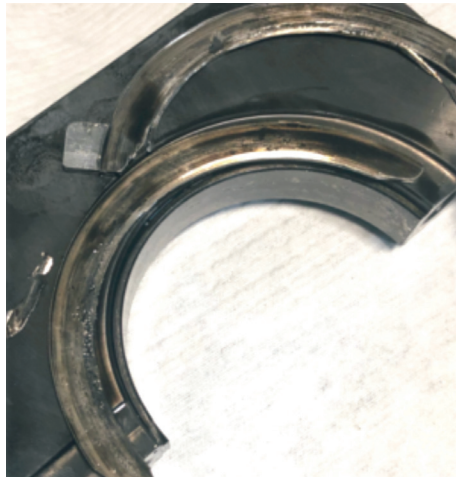
**Failed Thrust Bearing**

In this article, the objective is to point out areas that can singularly or combined, result in thrust bearing failures. These attributes are likely not to be considered as the root cause of the failure because the evidence is destroyed or the lack of knowledge about the rest of the assembly leaves too many questions.
