Piston to Rod Assembly on 2001-2016 GM 6.6L Duramax Diesel Engines

The AERA Technical Committee offers the following information regarding piston to rod assembly information on 2001-2016 GM 6.6L Duramax diesel engines. This information should be referenced anytime piston removal is being considered.

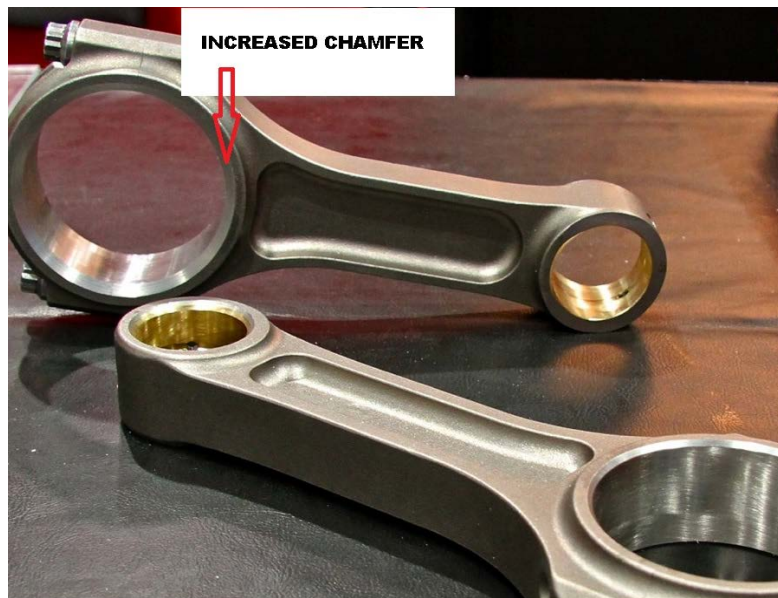
Information provided by General Motors for reassembly only references the big end chamfer and the side with increased chamfer should face the crankshaft rod fillet radius. Doing so will face four of those increased chamfers to front of the block and four increased chamfers to the rear of the block.

The connecting rods for this engine are not physically marked for an assembly direction. Marking them with a pen type marker is suggested during disassembly is suggested for easier re-assembly.

NOTE: It is also recommended by General Motors to replace the connecting rod bolts during engine assembly anytime they've been removed as they are a one-time use bolt.
